**Flood Control Project Maintenance  
Levee Inspections**  
**LMA District Cover Sheet**  
**Spring 2018 Levee Inspection Results**

**Reclamation District No. 0404 Boggs**

**Spring 2018 Levee Inspection Results**

**Levee Inspection Report By Mile - Spring 2018**

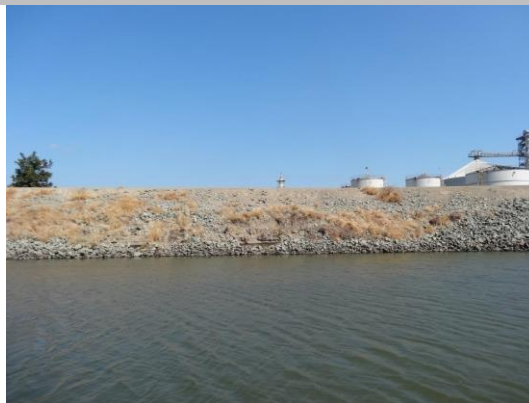
Photo 1 of 3 : SP\_2018\_RD0404\_305\_6\_20180323\_00002.jpg

Front view of the erosion.

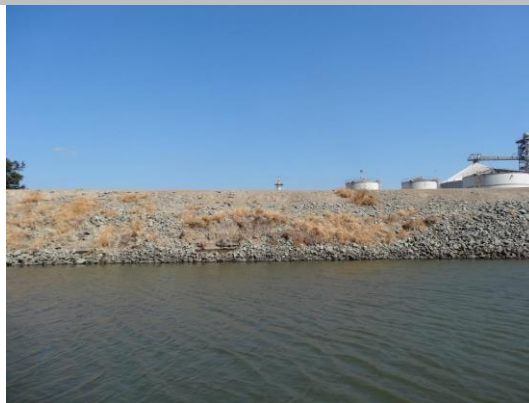
Photo 2 of 3 : SP\_2018\_RD0404\_305\_6\_20180323\_00003.jpg

Front of the erosion.

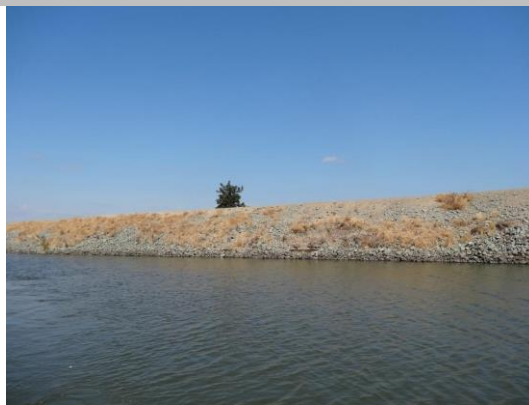
Photo 3 of 3 : SP\_2018\_RD0404\_305\_6\_20180323\_00004.jpg

Looking downstream at the erosion site.

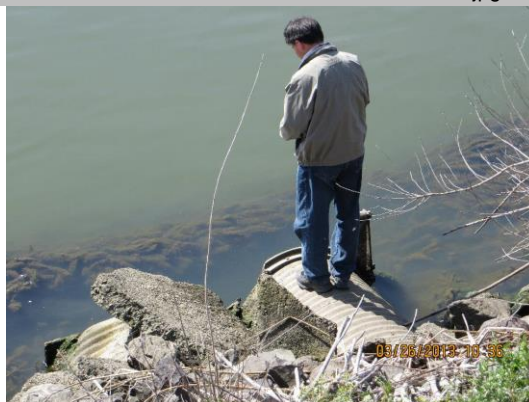
Photo 2 of 3 : UCIP\_SP\_2018\_51163\_20081.jpg

WS- left CM pipe with missing flap gate

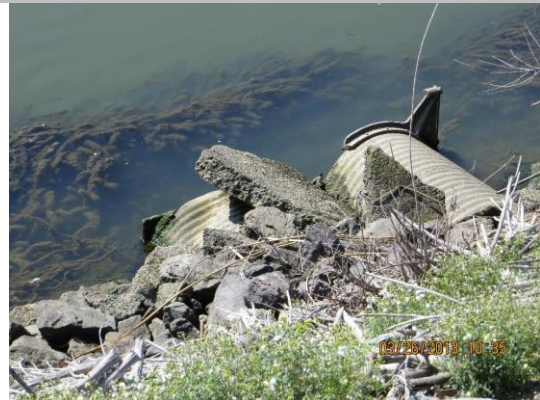
Photo 1 of 3 : UCIP\_SP\_2018\_51164\_20086.jpg

Comment Code						
Inspector Comment						
FS_ID:51164 DS_ID:22969 EP_NO: N/A Repair Type: Urgent Crossing Status: Found UCIP Comments: 11/29/2016 Flap gate appears to be either missing or broken. Pipes submerged on WS with concrete block on one pipe during inspection. No pipes found on LS. (K. Fazel - UCIP)03/29/2013 Pipe has broken flap gate. (P. Amatya - DWR) FIELD_STRUCT_DESC: 2 of 2: 36-inch corrugated metal gravity drainage pipe through the levee, approximately 18 feet below the crown. Pipe may not fully penetrate the levee as it does not daylight on the landside (LS). This drainage pipe was field discovered with no mention of it in any reference. FS Date: 11/29/2016

WS- two CM pipes with damaged flap gates

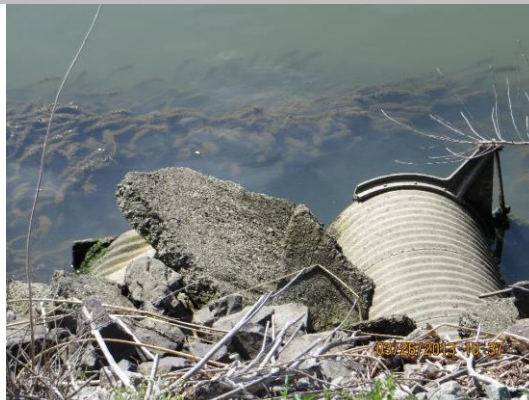
Photo 3 of 3 : UCIP\_SP\_2018\_51164\_20084.jpg

WS- closer view of right CM pipe with damaged flap gate

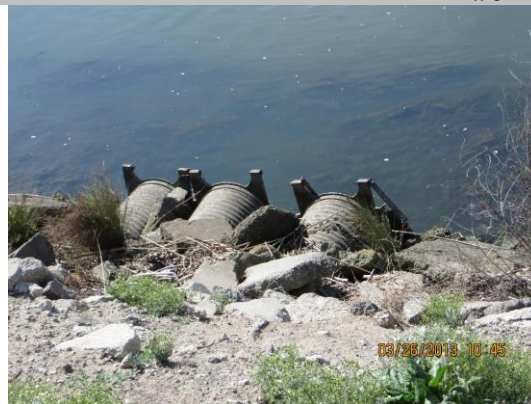
Photo 2 of 3 : UCIP\_SP\_2018\_51167\_20053.jpg

Comment Code					
Inspector Comment					
FS_ID:51167 DS_ID:18810 EP_NO: N/A Repair Type: Urgent Crossing Status: Found UCIP Comments: 12/13/2016 Since previous inspector and 2006 Levee Log cite damage to flap gate, I have upgraded this crossing from Non-Urgent to Urgent. Flap gates need to be in good working condition. (K. Fazel - UCIP)03/26/2013 Steel intake structure on LS. (P. Amatya - DWR)12/26/2006 Landward end filled with dirt. Middle flap gate missing and right flap gate broken as of 1/24/07. (DWR Levee Log) FIELD_STRUCT_DESC: 3 of 3: 30-inch corrugated metal gravity drainage pipe through the levee, 22 feet below the crown. Flap gate on the waterside (WS) end. Steel intake structure on the landside (LS). [Additional Reference(s): DWR Levee Log, 2006]. FS Date: 3/26/2013

WS- CM pipes with damaged flap gates

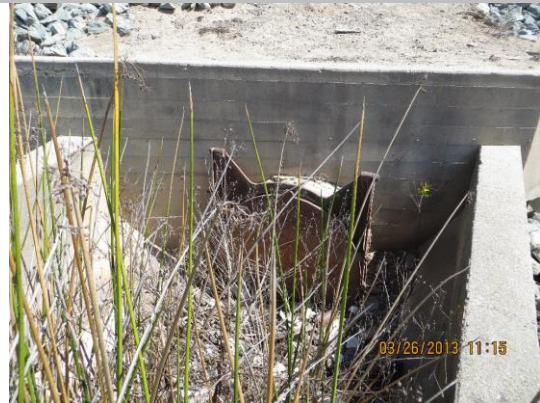
Photo 3 of 3 : UCIP\_SP\_2018\_52607\_19961.jpg

Item	DWR UCIP LMA Responsibility			37.937657 °	37.937657 °	
				-121.334158 °	-121.334158 °	
DWR ID						
Comment Code						
Inspector Comment						
FS_ID:52607 DS_ID:17945 EP_NO: N/A Repair Type: No Action Needed Crossing Status: Found UCIP Comments: 11/22/2017 Received updated photo from DWR levee inspector D. Torres showing gate has been cleared of sediment to allow operation of the gate on the WS. Crossing has been downgraded from Urgent to No Action Needed based on the 2016 photos and the most current photo. Recommend coordinating with City of Stockton to determine as-builts, CVFPB permit, and date of last internal integrity inspection completed for this crossing. (DWR UCIP - O. Magana)  11/29/2016 Flap gate still buried with sediment on WS. Requires clearing. (K. Fazel - UCIP)03/26/2013 Partially buried flap gate (P. Amatya - DWR) FIELD_STRUCT_DESC: 42-inch corrugated metal drainage discharge pipe, 18 feet below the crown. Flap gate, concrete headwall, and spillway on the waterside (WS). Pump house on the landside (LS). Abandoned concrete headwall, power pole, and two wooden piles found on the LS. This drainage pipe likely belongs to the City of Stockton. [Additional Reference(s): DWR Levee Log, 2006. USACE San Joaquin O&M Manual 1, March 1963, (HLM 0.78)]. FS Date: 11/22/2017

WS- Debris and vegetation blocking CM drainage pipe

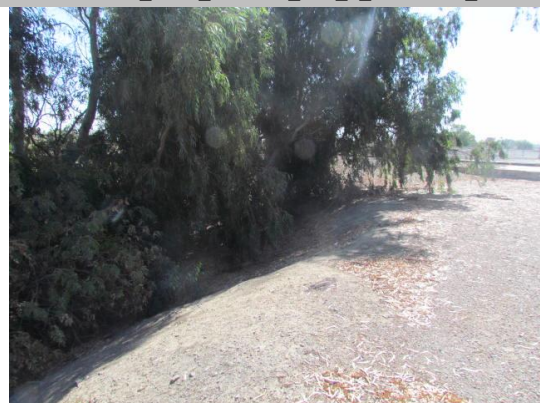
Photo 1 of 1 : SP\_2018\_RD0404\_305\_8\_20180323\_00005.jpg

LM Start	0.78	Rating **	A/W	Issue No.	8
LM End	0.78	Issue Type +	Ma	Location *	LS
Category	Earthen Levee			GPS Latitude/Longitude	
				Start	End
Item	Trim / Thin Trees			37.937395 °	37.937395 °
				-121.333883 °	-121.333883 °
DWR ID	DWR_RD0404_01_s_2013_8				
Comment Code					
T1 : Trim trees to at least five feet above ground level.					
Inspector Comment					
Trees are blocking view of the slope.

Looking southeast at dense trees on landward slope and toe.

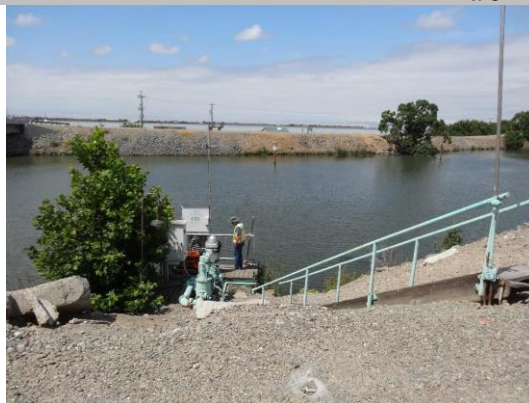
Photo 2 of 3 : UCIP\_SP\_2018\_46801\_74747.jpg

WS view: pump with shutoff valves, headwall, stairs visible. Concrete debris along WS slope.

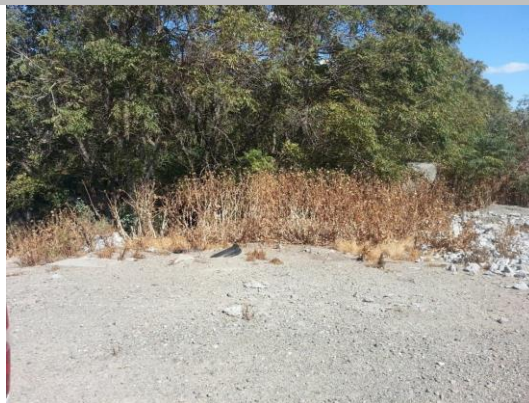
Photo 1 of 2 : SP\_2018\_RD0404\_305\_101\_20180323\_00021.jpg

Looking east at dense vegetation on landward slope. (Fall 2016)

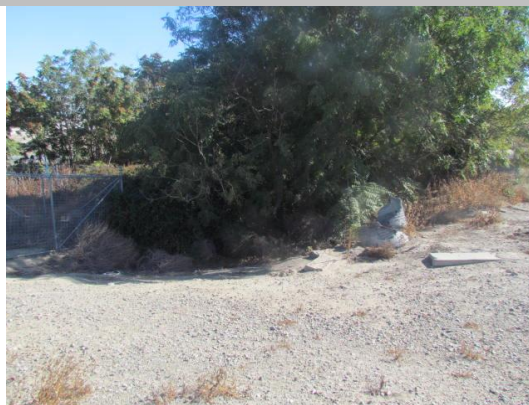
Photo 2 of 2 : SP\_2018\_RD0404\_305\_101\_20180323\_00022.jpg

Looking southeast at overhanging trees on landside slope. (Fall 2015)

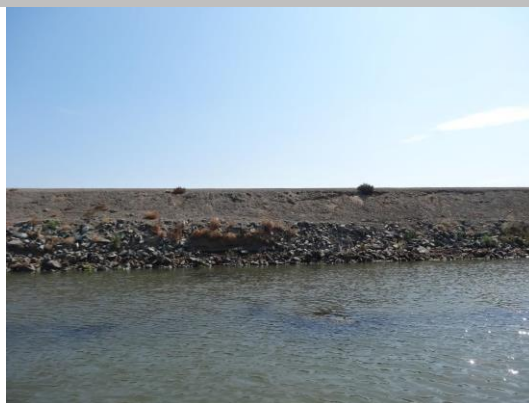
Photo 2 of 2 : SP\_2018\_RD0404\_305\_11\_20180323\_00007.jpg

Close view of the erosion. Note the protection on the lower levee slope.

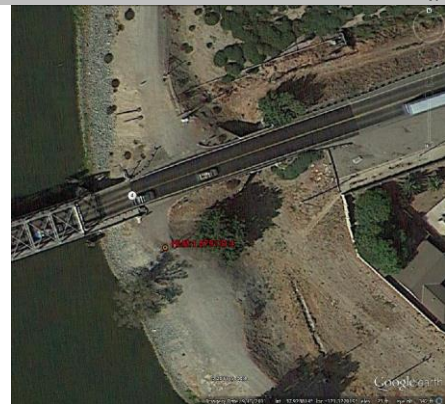
Photo 1 of 1 : UCIP\_SP\_2018\_12386\_20062.jpg

Aerial Photo @HLM=1.5791: No sign posts/markers found.

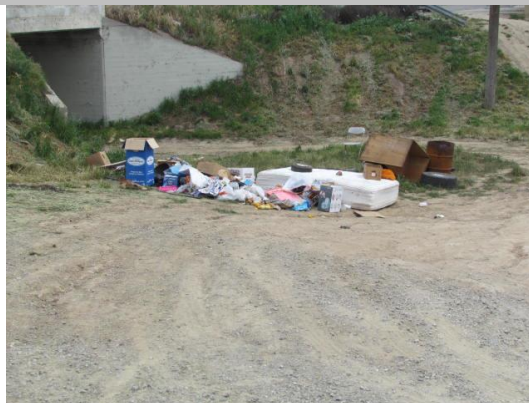
Photo 1 of 1 : SP\_2018\_RD0404\_305\_36\_20180323\_00017.jpg

Looking east at garbage on landward slope and toe.

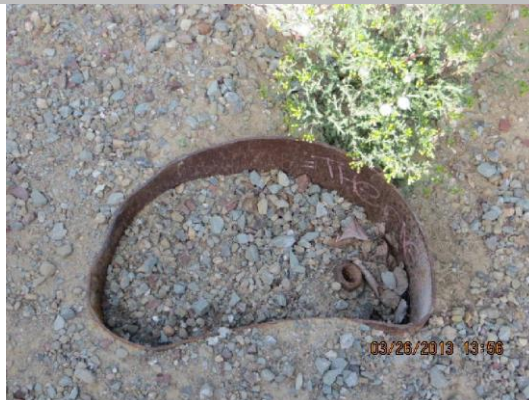
Photo 3 of 3 : UCIP\_SP\_2018\_40797\_20071.jpg

LS- damaged and obstructed siphon breaker on levee shoulder.

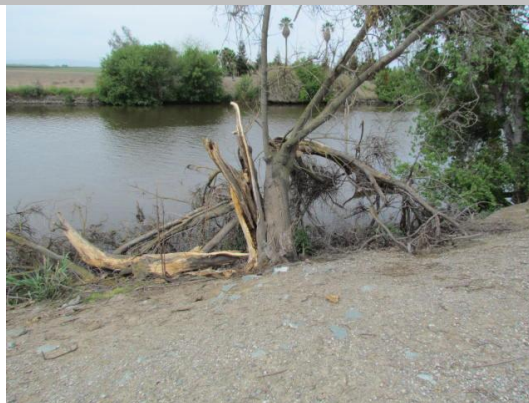
Photo 1 of 1 : SP\_2018\_RD0404\_305\_33\_20180323\_00016.jpg

Looking west at dead tree on waterward slope.

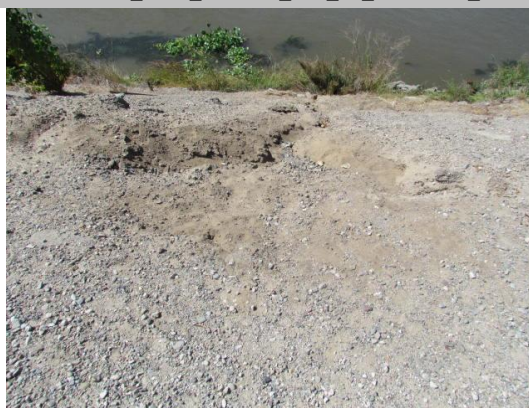
Photo 1 of 2 : SP\_2018\_RD0404\_305\_16\_20180323\_00009.jpg

Looking west at slope damage due to foot traffic.

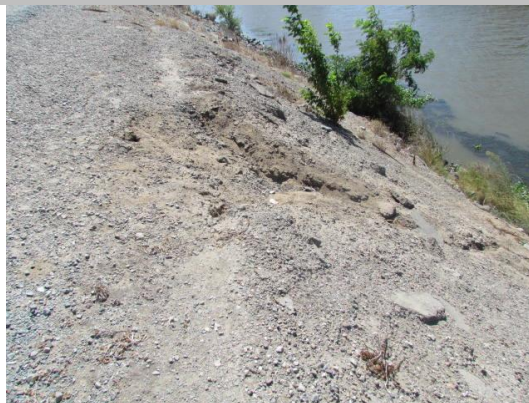
Photo 2 of 2 : SP\_2018\_RD0404\_305\_16\_20180323\_00010.jpg

Looking southwest at slope damage due to foot traffic.

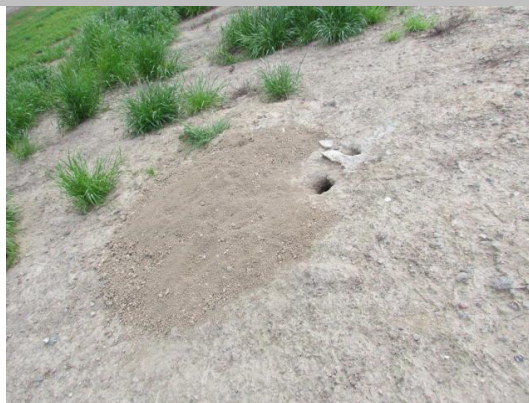
Photo 1 of 2 : SP\_2018\_RD0404\_306\_21\_20180323\_00009.jpg

Looking northeast at large rodent hole on landward slope.

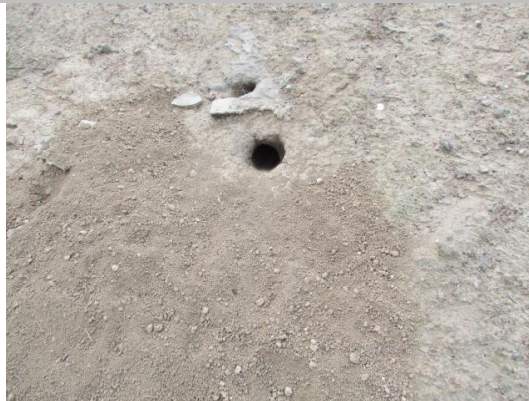
Photo 2 of 2 : SP\_2018\_RD0404\_306\_21\_20180323\_00010.jpg

Looking east at large rodent hole on landward slope.

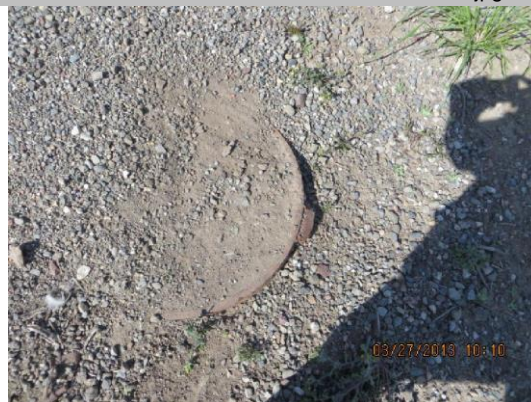
Photo 2 of 3 : UCIP\_SP\_2018\_10908\_18181.jpg

WS- damaged, obstructed and buried siphon breaker

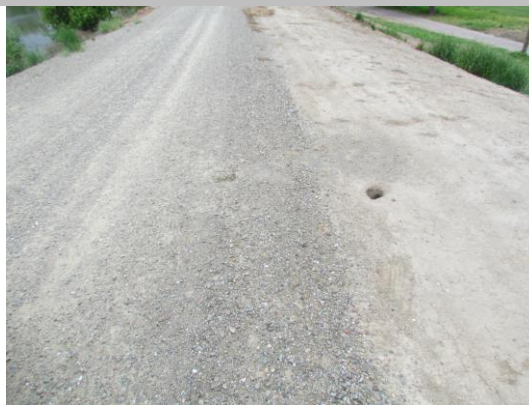
Photo 2 of 4 : SP\_2018\_RD0404\_306\_20\_20180323\_00006.jpg

Looking northeast at rodent hole on landward shoulder.

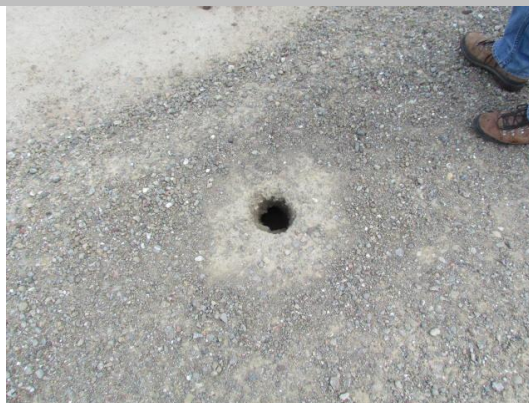
Photo 3 of 4 : SP\_2018\_RD0404\_306\_20\_20180323\_00007.jpg

Looking at rodent hole on levee crown.

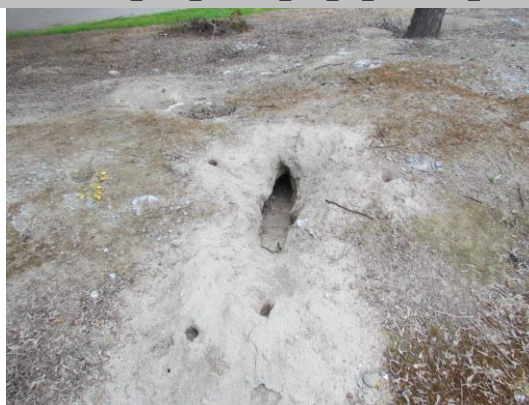
Photo 1 of 2 : SP\_2018\_RD0404\_306\_11\_20180323\_00001.jpg

Looking east at large rodent hole on landward slope.

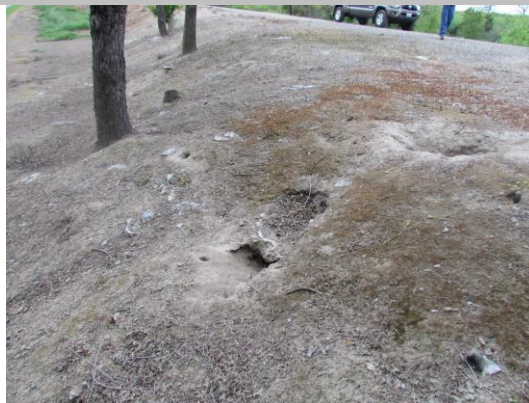
Photo 2 of 2 : SP\_2018\_RD0404\_306\_11\_20180323\_00002.jpg

Looking southwest at several rodent holes on landward slope.

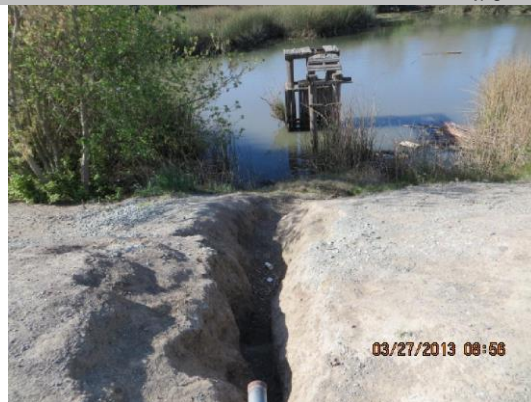
Photo 2 of 3 : UCIP\_SP\_2018\_51171\_18133.jpg

WS- soil erosion and gully formation due to leaky pipe
